## Dodge® Quantis gear reducers: allowable misalignment

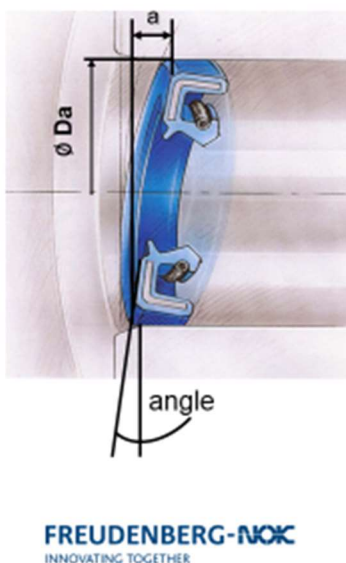
One cause of gearbox output seal leaking that can be overlooked is seal misalignment or seal cock. If the seal is pressed into the reducer and is slightly skewed, this can result in an oil leak from the gearbox. Ideally, the seal must be installed concentric and right angled with the shaft it rides on.

The amount of allowable misalignment will depend on the type of seal and the supplier. For Quantis gearboxes, the seals are supplied by Freudenberg-NOK. Quantis output seals can have up to  $0.5^\circ$  of misalignment according to Freudenberg-NOK. The figure below shows a seal in misalignment with a shaft.

**Figure 1.** Misaligned seal example

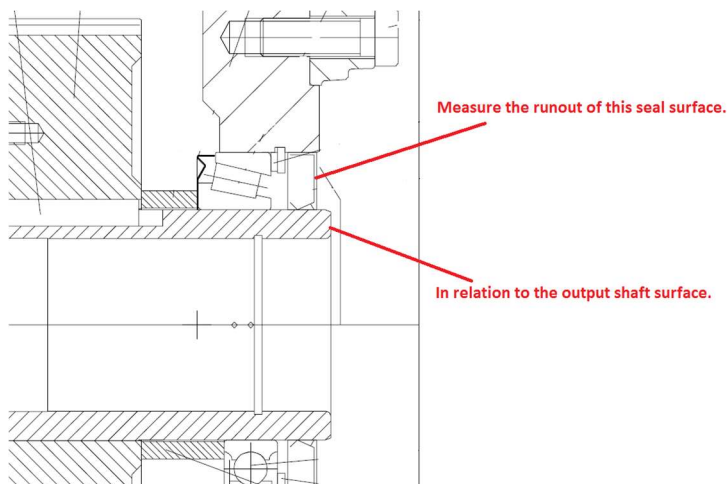
The best method for measuring Quantis output seal misalignment is to measure the runout of the seal in relation to the output shaft using a dial indicator. **Figure 2** displays the locations where you can measure the runout of the seal in relation to the shaft.

Figure 2. Location for dial indicator to measure seal runout.

Using trigonometry, we can find the maximum allowable runout of the seal based on the seal OD and the 0.5° allowable misalignment.

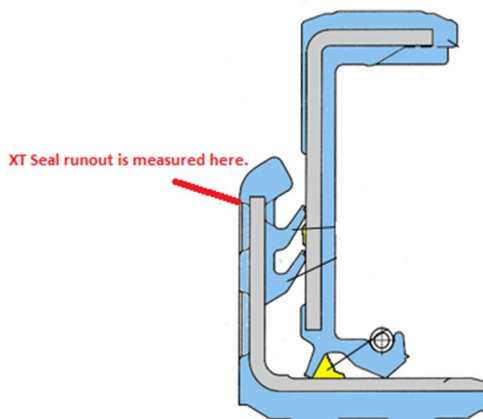
Quantis XT seals have the same OD so they have same maximum allowable runout as standard output seals. But the location to measure the runout is different. You must place the dial indicator on the face of the inner seal in reference to the shaft. See figure 3.

Figure 3. XT Seal runout measurement location.
