Dodge TAI/MTAI Excessive Gearbox Movement

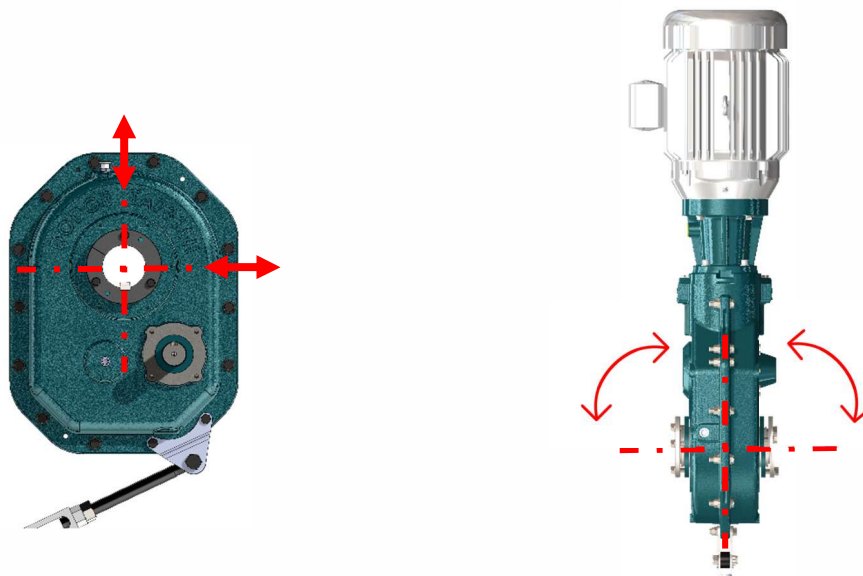
Figure 1: Gearbox Hop (left) and Wobble (right)

Both conditions will most likely always be present due to tolerances in the gearbox manufacturing process as well as customer shaft tolerances. A little natural movement in a gearbox during operation is acceptable but too much can be detrimental. The question remains - what amount of movement is excessive while a gearbox is in operation? It is difficult to define excessive gearbox movement, but this technical paper will aid in troubleshooting excessive gearbox movement during operation.

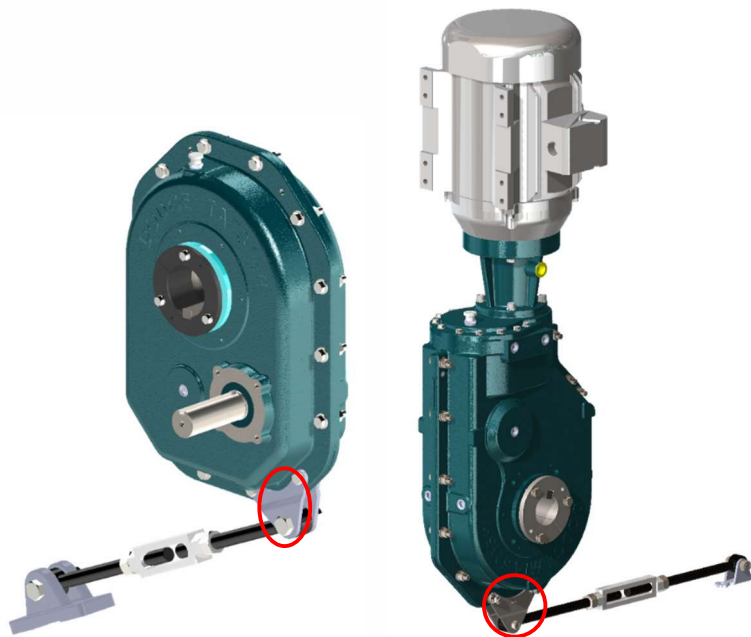
Figure 2 shows an example of the location to take this measurement. Note that the gearbox may be oriented in a different mounting position than shown in the figure. The tie rod housing brackets need to be identified then a measurement taken on a flat spot on the bracket itself or possibly on the head of the bolt where the connection is made. These locations need to be in line of sight of the measuring device focused around the area circled in the figure.

Figure 2: Example Location for Wobble Measurement

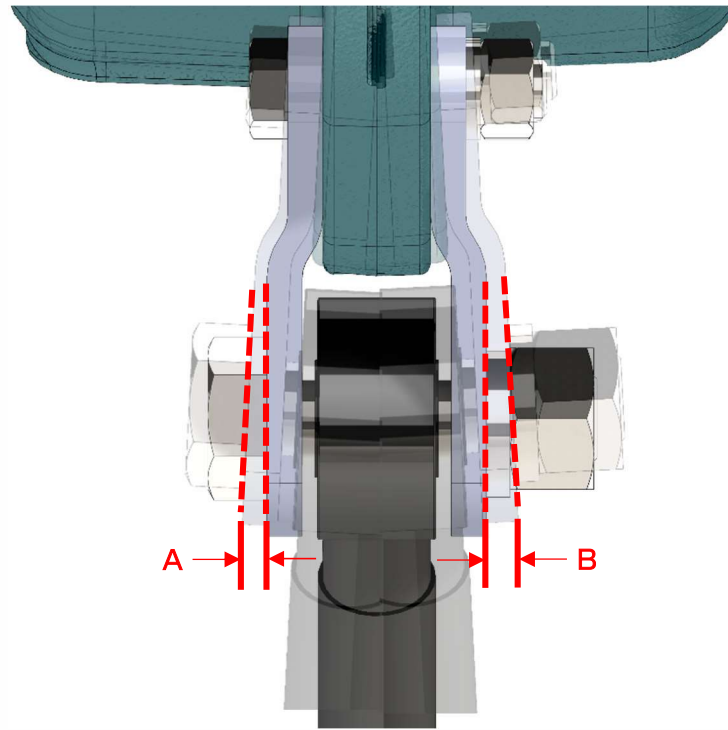
An example of maximum movement is given in Figure 3 from a profile view. This is meant to portray a gearbox that experiences wobble while in operation. Once a location is chosen to take the measurement from the previous figure, then a maximum and minimum value needs to be found. Figure 3 shows an example of the movement where total axial displacement would be equal to "A" + "B". Dimension "A" is the maximum movement from centerline to one end of travel and dimension "B" is the maximum movement from centerline to the other end of travel. The sum of these would be equal to the maximum movement, which should not exceed 1/4" total (+/- 1/8"). Typically, laser measuring devices have a setting to find maximum movement from a stationary measuring location.

Figure 3: Profile Wobble Movement Example
