Dodge Application Engineering December 11, 2021

Dodge Tigear 2 Motor Rotation Instructions

The "Dodge Tigear 2 Motor Rotaion Instructions" were designed to assist in motor rotation for the purpose of repositioning the motor conduit box position.

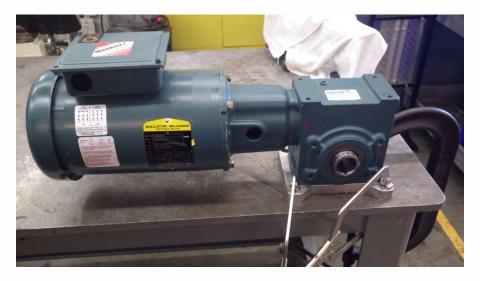
• Secure the reducer & motor in the horizontal position on a table or other suitable surface.

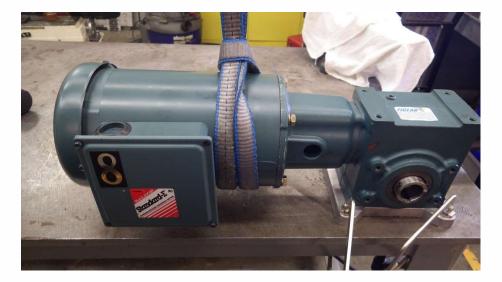
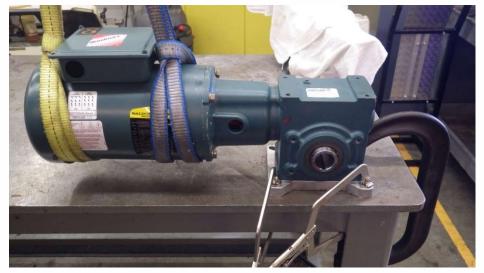
Install a certified nylon lifting strap around the motor's barrel. The strap should be installed using the choker method to safely secure the motor. The strap can be installed on either side of the conduit box. Installation on the shaft side of the conduit box normally works easier during motor rotation. On larger frame motors, two lifting straps should be installed. One strap on each side of the conduit box. Tighten the lifting strap / straps until snug. CAUTION: Do not over tighten strap / straps. This will cause the tenon joint to bind making separating the motor from the reducer difficult.

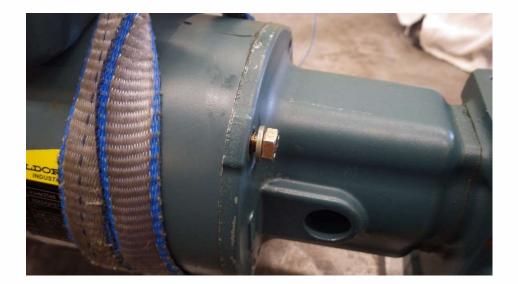
• Remove two of the four motor mounting capscrews and loosen the two remaining capscrews approximately .25". This distance allows the motor tenon to be separated from the reducer tenon without allowing the three piece coupling halves or quill shaft to disengage. Separate the motor tenon from the reducer tenon by lightly rapping the motor frame with a dead blow hammer while applying axial pressure opposite the motor shaft or by prying the tenon joint apart with two flat blade screwdrivers. Care should be used when using screwdrivers to separate the tenon joint. If the tenon surfaces are damaged, the motor and reducer will have to be completely separated to repair the damage.

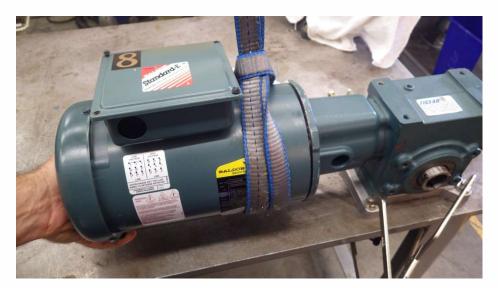
Once the motor tenon has been separated from the reducer, support the motor fan end and keep constant axial pressure on the fan shroud towards the reducer. This pressure is required to keep the three piece coupling halves from disengaging and must be maintained throughout the motor rotation procedure. Remove the two remaining motor mounting capscrews.

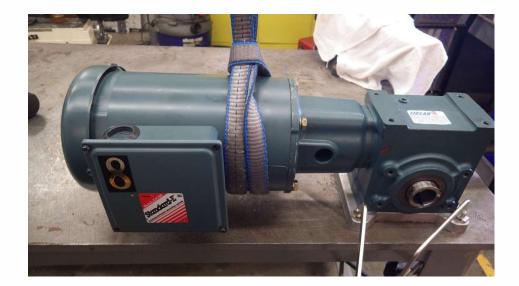
Slowly rotate the motor to the desired conduit box position. The lifting strap / straps may
have to be manually rotated in the opposite direction once or twice during the rotation
procedure. Verify the motor gasket is in its proper position to allow the motor mounting
capscrews to be re-installed. Installed the four motor mounting capscrews and lock
washers. Tighten the capscrews to their recommend to torque value.

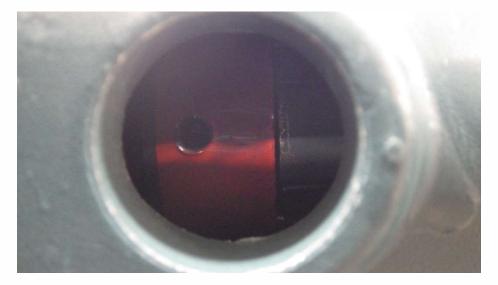
Look into the coupling access hole and verify the three piece coupling is properly engage.

- If the three piece coupling halves become disengaged during this procedure, rotate the motor to the desired conduit box position. Realign and engage the coupling halves and motor / reducer tenon joint. Install motor mounting capscrews and lock washers.
- Relocating the coupling on the motor shaft or re-torqueing the coupling setscrew (setscrews) is not required unless the coupling setscrew (setscrews) has been loosened during the motor rotation procedure.
